RE: Docket Number FAA-2019-0853
Product Identifier 2019-CE036-AD

November 7, 2019

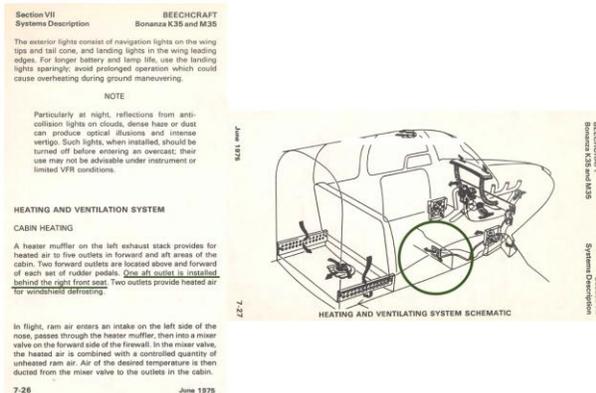
(left) Figure 1

Excerpt from the Beech Pilot's Operating Handbook for K35 and M35 Bonanzas. The heater system is described as having only one aft outlet behind the right front seat. The POH illustration confirms this single aft outlet on the back side of the forward spar carry-through. The K35 and M35 do not have the extended heater duct that travels over the right aileron cable and turnbuckle, so the K35 and M35 are not affected by the issue addressed in AD 2019-21-08.

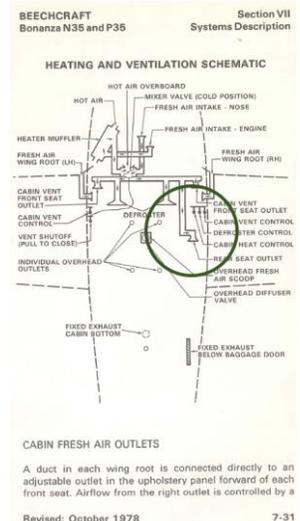
(right) Figure 2

Excerpt from the Beech Pilot's Operating Handbook for N35 and P35 Bonanzas. Although it is presented differently from the earlier models, the POH illustration confirms the N35 and P35 also have only a single aft outlet on the back side of the forward spar carry-through. The N35 and P35 do not have the extended heater duct that travels over the right aileron cable and turnbuckle, so these models are also not affected by the issue addressed in AD 2019-21-08.
