National Transportation Safety Board

Safety Recommendation

Date: February 24, 2012

In reply refer to: A-12-7

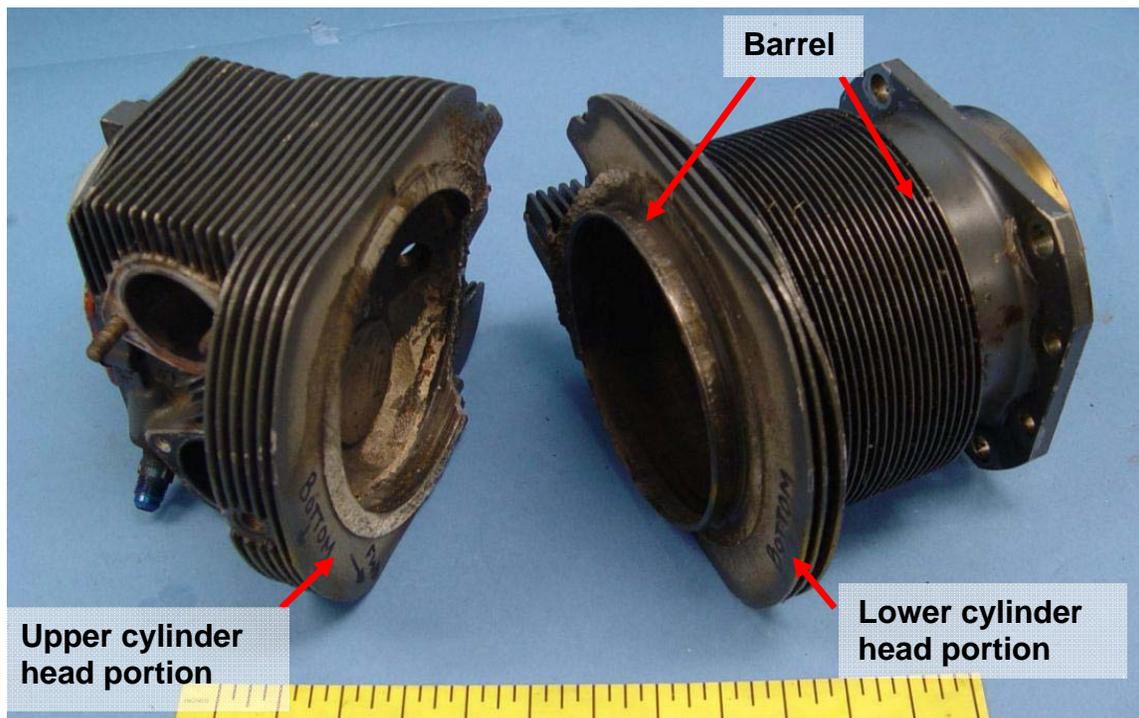
In most of the cases examined by the NTSB, the fatigue cracks in the cylinder heads initiated at the root of the thread that was engaged with the first (uppermost) thread on the cylinder barrels, as shown in figure 1 and indicated by the yellow line in figure 2. The fatigue cracks propagated outwards through the cylinder head wall to emerge between the third and fourth or the fourth and fifth cooling fin, depending on the engine model. The fatigue cracks initiated at multiple locations, typically near the intake or exhaust valve side of the cylinder heads and, with engine use, propagated through the head thickness. Once the fatigue cracks propagated through the thickness of the cylinder wall, the cylinders lost compression, with a resulting reduction in or total loss of thrust. When the fatigue cracks reached a critical size, the cylinder heads fractured and separated at the fatigue location, with the lower portion remaining attached to the barrels, resulting in catastrophic engine failure.

Figure 1. Photograph of a fractured cylinder assembly.

Require repetitive inspection of Engine Components, Inc. cylinder assemblies produced between May 2003 and October 2009 (serial numbers 7709 through 52884) installed on Teledyne Continental Motors model 520 and 550 engines and removal of these cylinder assemblies once they reach the engine manufacturer's recommended normal time (hours) in service between overhauls.
(A-12-7)

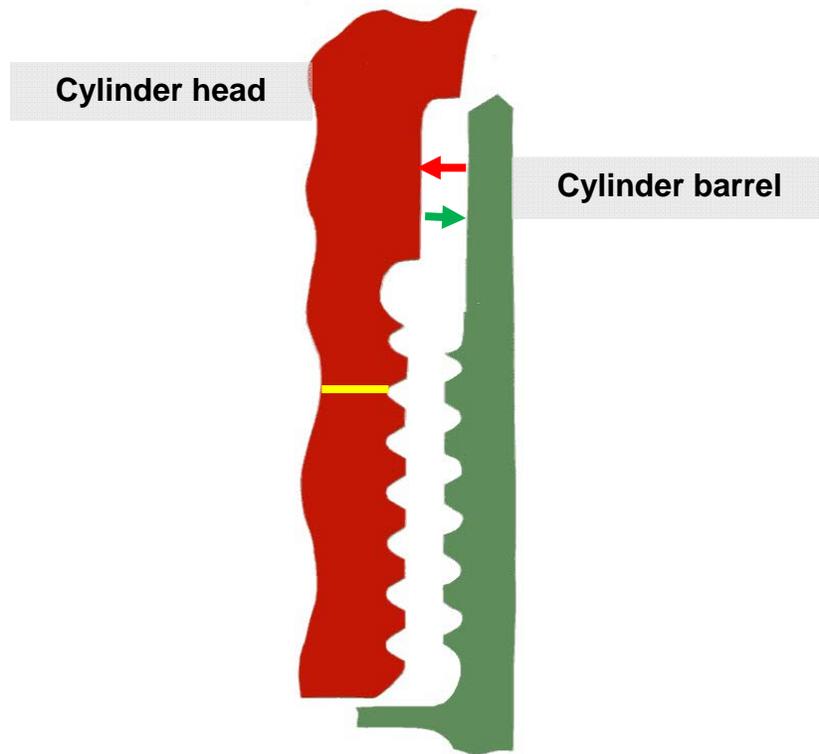
Figure 2. A sectional view of an ECI cylinder head and barrel, showing the location of fatigue cracking (yellow line) and shrink bands (red and green arrows).

simulates the cylinder head temperature and pressure cycles experienced by a cylinder on an operating engine. After running numerous tests, ECi changed the manufacturing process for its cylinder assemblies in October 2009 to provide an increased interference fit at the shrink band and between the cylinder head and the cylinder barrel threads but remaining within the limits of the approved design.
