SERVICE BULLETIN

TITLE: FLIGHT CONTROLS - CONTROL COLUMN HARDWARE REPLACEMENT

This Service Bulletin is being issued because Beechcraft Corporation (BC) has received two (2) reports of control column binding. One report was found on preflight and the other was found during landing. It was subsequently determined that both incidents were the result of hardware binding in the pilot's control column.

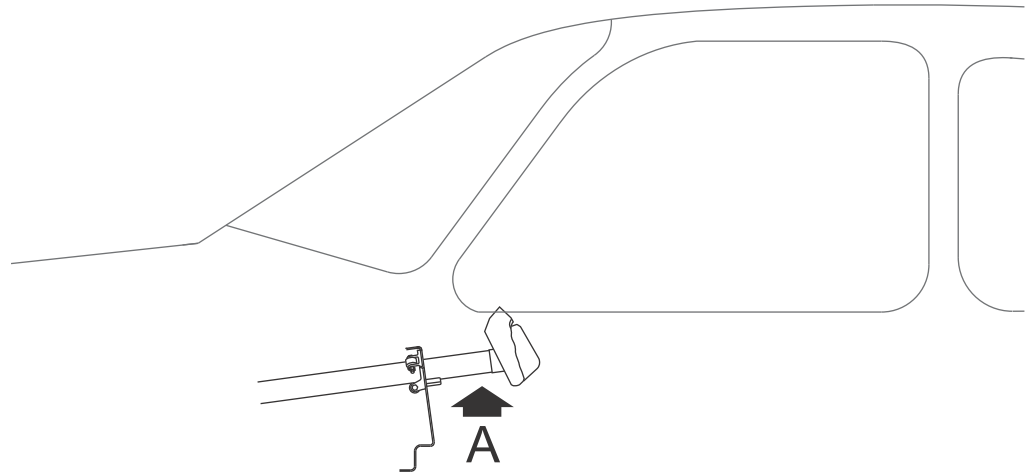
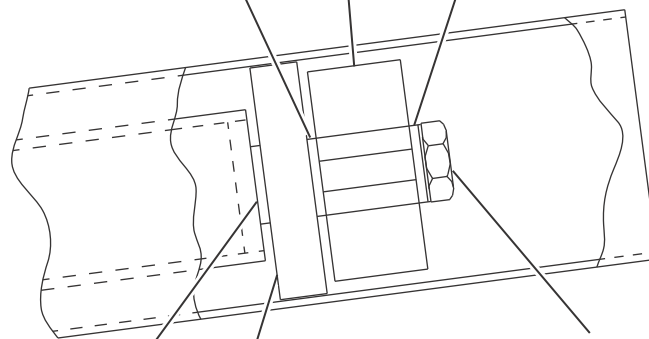
Figure 1

CONTROL COLUMN SHOWN
WITH CONTROL WHEEL AND
CONTROL WHEEL ADAPTER REMOVED.

Control Column Hardware Replacement

- (f) Apply chemical conversion coating to bare metal surfaces. Allow adequate drying time following application of chemical conversion coating.
 - (g) Remove bolt P/N AN4-24A (Baron) or bolt P/N AN4-14A (Bonanza), from the center of the control column. Refer to Figure 1.

- (h) Remove the following items from the bolt:
 - Washer P/N AN960-416. Discard washer.
 - Guide assembly P/N 60-524101-0005. Discard guide assembly.
 - Washer P/N NAS1149F0463P. Discard washer.

- Spacer P/N 36-524091-15 (Bonanza) or P/N 36-524091-17 (Baron). **Retain the spacer.**
 - (i) Discard the bolt.
- (3) Refer to Figures 1 through 4 and reassemble the control column as follows:

- (a) Place new bushing P/N 60-524101-9 on hard surface.
 - (b) Place new guide P/N 60-524101-7 over top of bushing and press down to install bushing in guide.

- (c) Adjust bushing position by pushing in or out so that the bushing protrudes 0.030-inch to 0.040-inch from the guide.

- (g) Install two (2) new lock washers, P/N MS35335-33, on the bolt, next to the spacer that was installed in Step (3)(f).
- (h) When adhesive that was applied in Step (3)(d) has properly cured, install guide assembly on the bolt, with P/N MS35335-35 washer on the opposite side of the guide from the P/N MS35335-33 washers.

- (i) Insert the bolt, which contains the grouping of parts installed in Steps (3)(e) through (3)(h), into the center of the control column as follows:

- (iii) Leave the tongue depressor in place to hold the guide assembly in position during the process of torquing the bolt to 50-70 inch-pounds over the free running bolt torque.

INSTALL 36-524091-15 SPACER, APPLICABLE TO BONANZA
INSTALL 36-524091-17 SPACER, APPLICABLE TO BARON

REMOVE AN960-416 WASHER
INSTALL MS35338-44 WASHER

INSTALL 2 MS35335-33 LOCK WASHERS

REMOVE AN960-416 WASHER
INSTALL MS35335-35 LOCK WASHER

REMOVE EXISTING AN4-24A BOLT
INSTALL NEW AN4-24A BOLT, APPLICABLE TO BARON
REMOVE EXISTING AN4-14A BOLT
INSTALL NEW AN4-14A BOLT, APPLICABLE TO BONANZA
TORQUE BOLT 50-70 IN-LBS

60-524101-5
INSTALL NEW GUIDE ASSEMBLY
