SERVICE BULLETIN

TITLE: FUEL - INSPECTION/REPLACEMENT OF FUEL CELLS

Model G58 Baron, Serials TH-2356 through TH-2378.

This Service Bulletin is being issued to address potential fuel leaks in defined fuel cells installed in the wings.

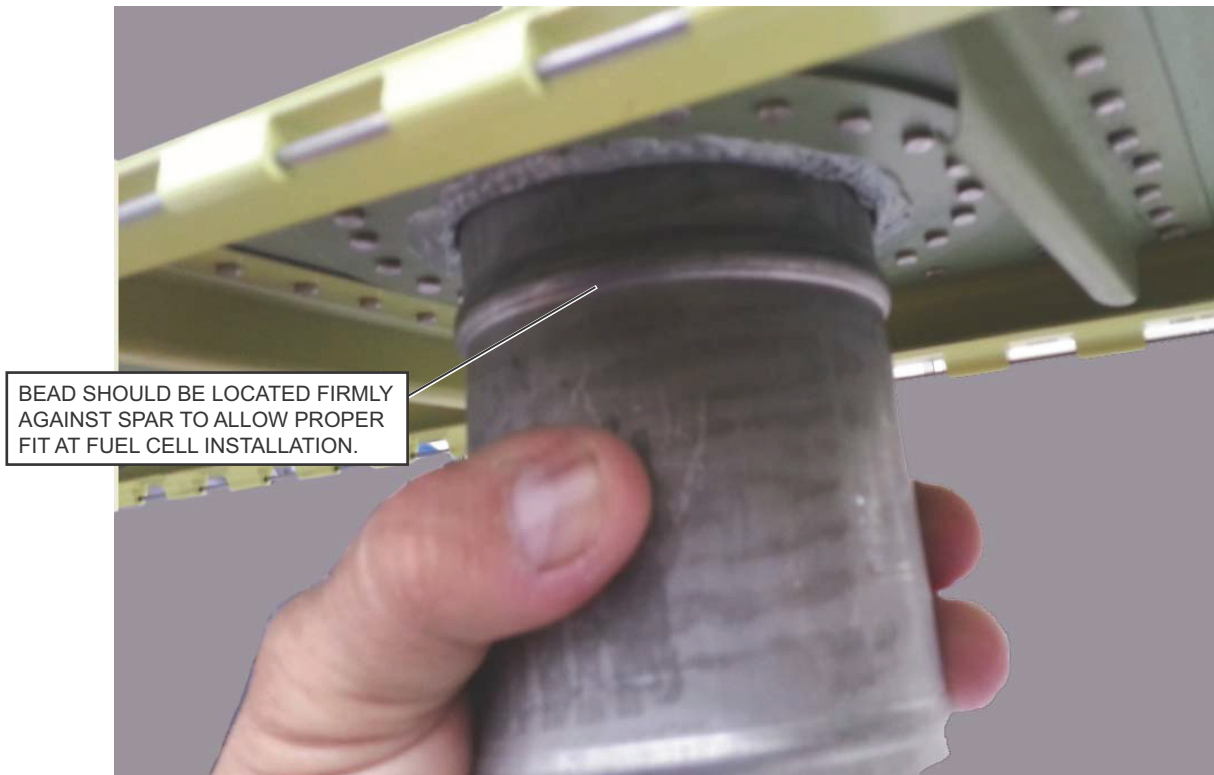
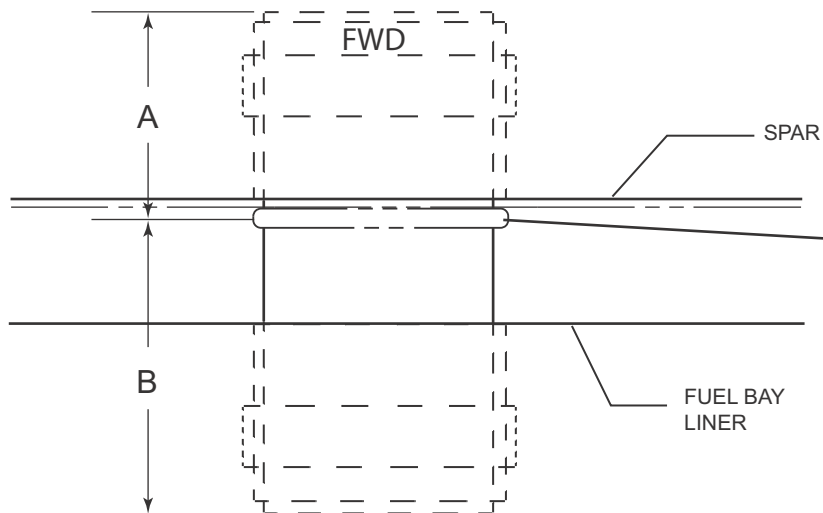
Fuel Cell Installation Requirements
Figure 3

THE MIDDLE BEAD OF THE INTERCONNECT TUBE SHOULD BE ON THE AFT SIDE OF THE SPAR. THE INTERCONNECT TUBE SHOULD BE STICKING OUT OF THE NIPPLE ON BOTH SIDES FOR THE MID-BOARD AND INBOARD TUBES. THE OUTBOARD TUBE SHOULD BE FLUSH OR SLIGHTLY IN OR OUT DEPENDING ON TOLERANCES.

VIEW SHOWING THE MIDDLE BEAD OF THE P/N 002-920012-51 OR -53 INTERCONNECT TUBE LOCATED ON THE AFT SIDE OF THE SPAR.

- (a) Apply forward pressure to the aft side of each interconnect tube. If the interconnect tube(s) are installed correctly the tube bead should come against the spar and not continue to the leading edge fuel cell area (Refer to Figure 3). If the interconnect tube is not installed correctly remove the interconnect tube and install correctly per Figure 3. If the tube is installed correctly proceed to the next step.

- (b) *The purpose of this step is to verify that the fuel cell is positioned tight against the spar. If the fuel cell is not tight against and supported by the spar, unintended loads could be induced on the fuel cell.* Hold forward pressure on the aft side of the interconnect tube(s), access the forward side of the interconnect tubes in the inboard and outboard leading edge fuel cells and ensure that the leading edge inboard and outboard fuel cells, at each interconnect tube, are tight against the forward side of the spar. If not tight, reposition nipple, ensuring it is tight against the forward face of the spar.
