POWERPLANTS

Continental: IO550C; Leaking Dipstick Housing; ATA 8550

AC 43-16A

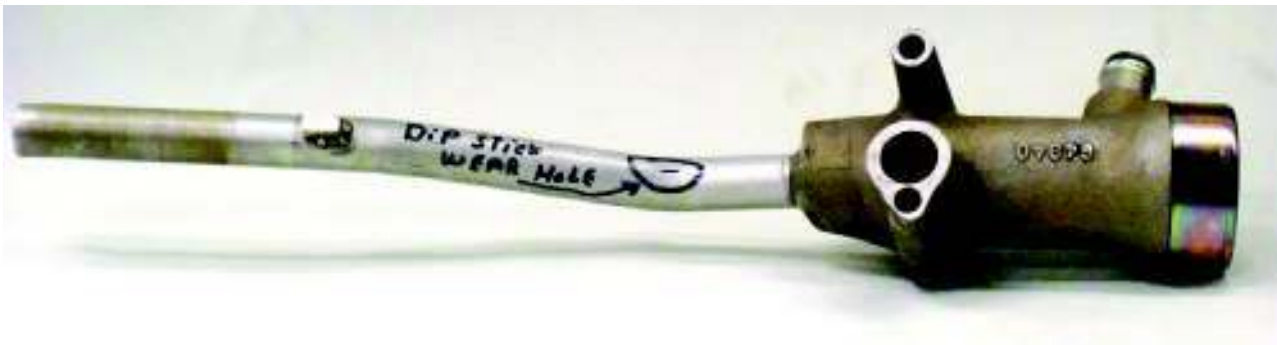
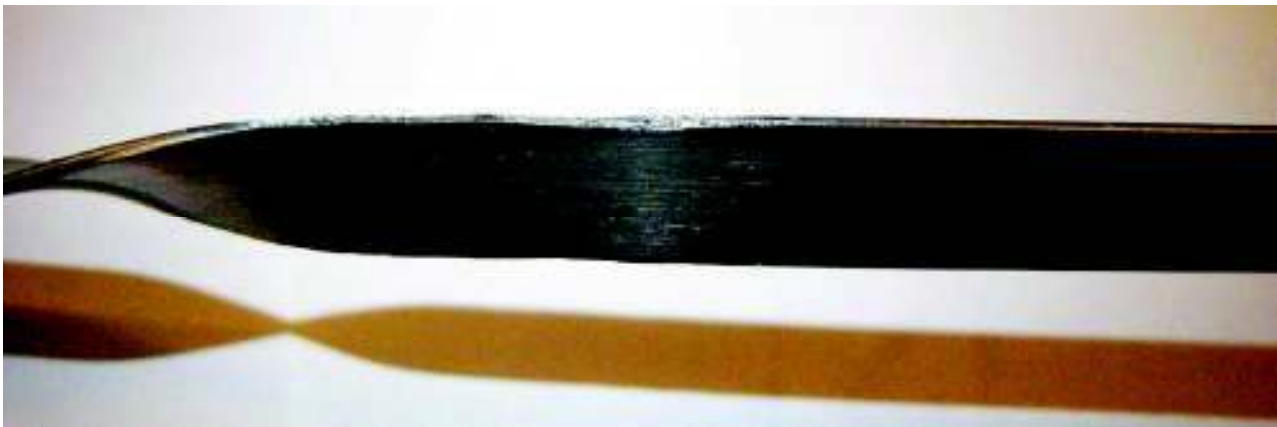
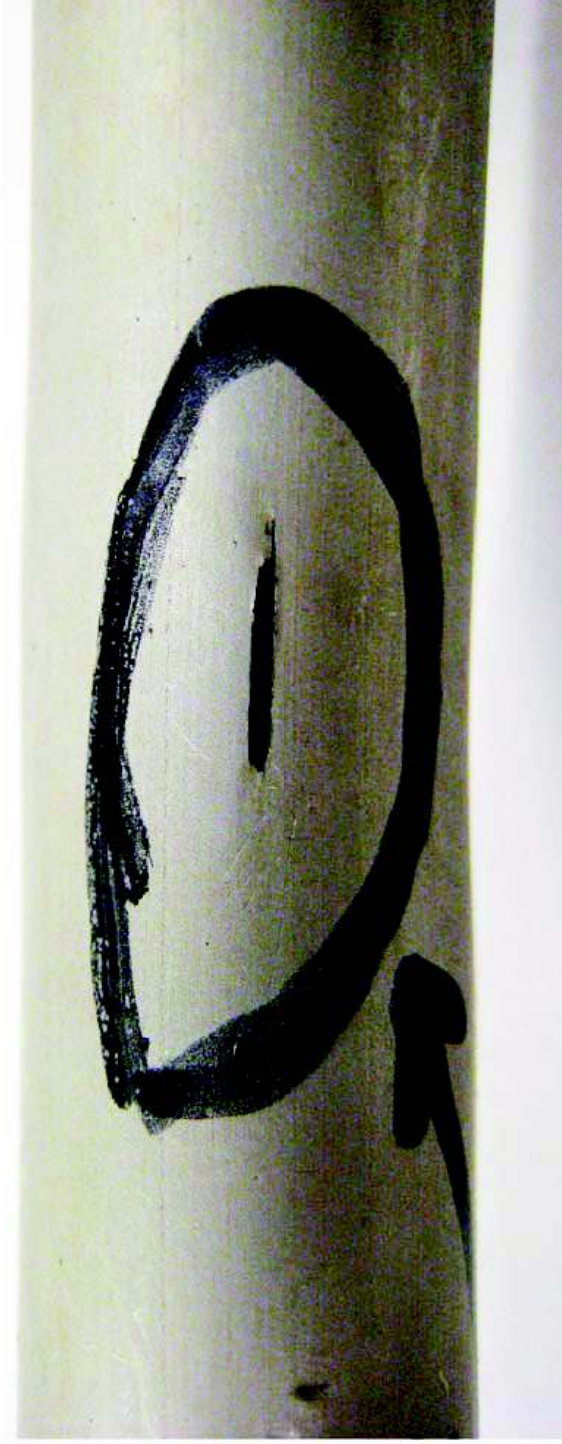
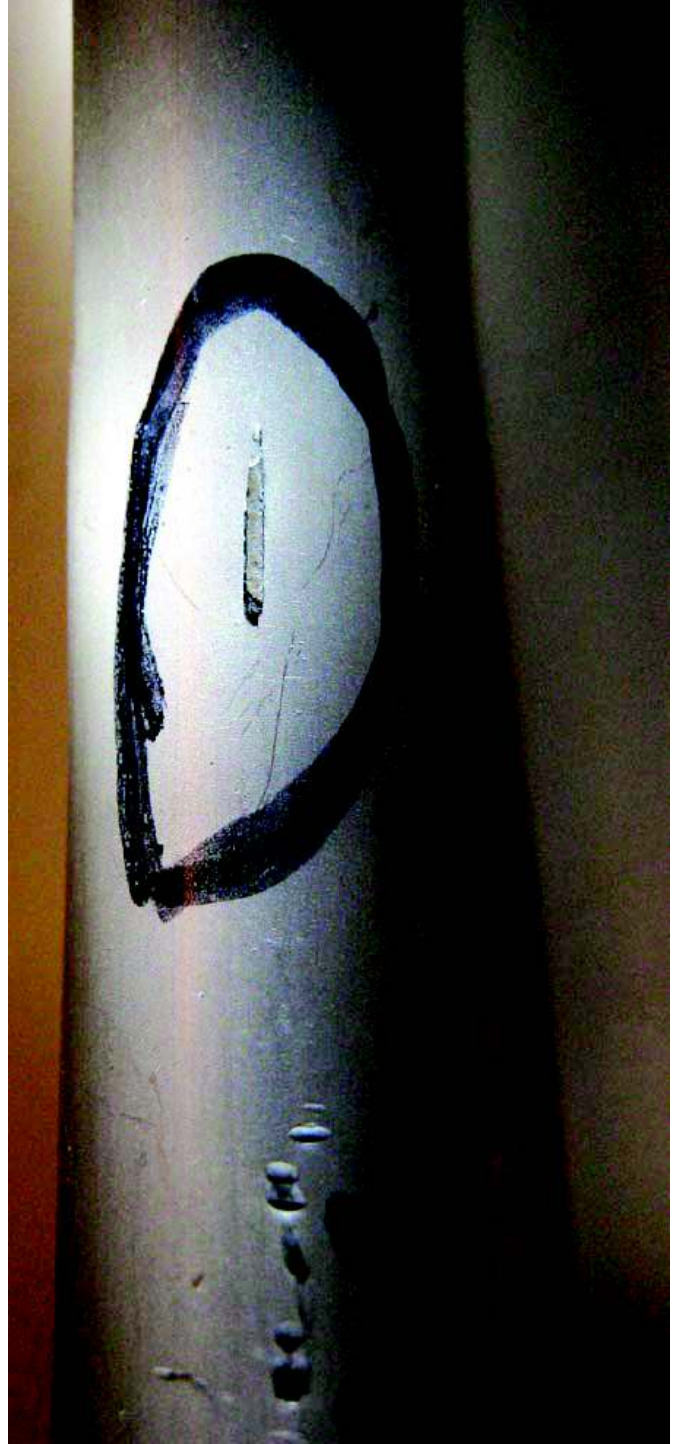
A technician states, "During a routine oil change a puddle of oil was observed in the bottom of the cowling. No oil was spilled while filling the crankcase. Having seen this problem several times in the past, the mechanic immediately knew to look at the dipstick tube (*P/N 6494061*) in the chafed area. As in all the previous situations, the hole is located at the first inside bend below the filler opening. Even though the OEM says they are not aware of the problem, most of our in-service engines show some sign of chafing which can be observed by looking down the oil fill opening on the crank case side of the tube. Fortunately, once the dipstick is in place, it tends to fill the chafed opening and very little oil can escape through the hole. The attached photos show the dipstick through the chafed hole—it actually creates a decent seal."
