**TELEDYNE CONTINENTAL[®] AIRCRAFT ENGINE
MANDATORY SERVICE BULLETIN**

**Category 1
MSB09-1**

SUBJECT: CYLINDER REPLACEMENT

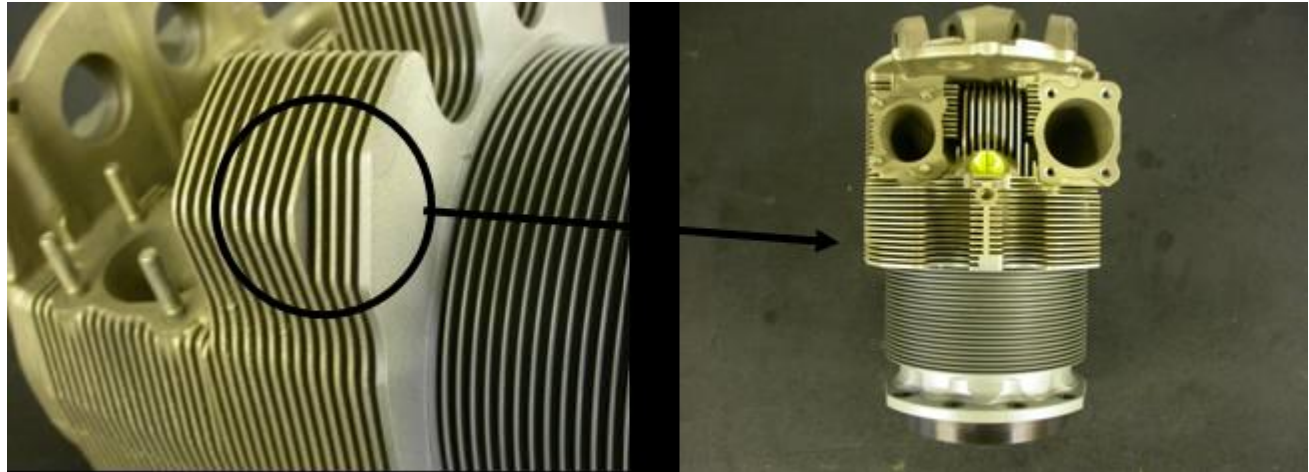
FIGURE 1
Cylinder Head Casting Four (4) Fin relief Location

The EQ3 head casting cylinder assemblies are identified by a four (4) fin relief at the bottom lower left hand portion of the cylinder head (as installed on the engine) and a depression cast EQ3 in the cylinder head rocker boss (overhead) area as shown in Figures 1 and 2. These cylinders are to be replaced in accordance with the guidelines set forth in this bulletin and based upon applicable engine model and aircraft manufacturer procedures. All EQ3 cylinders must be replaced no later than December 31, 2009.

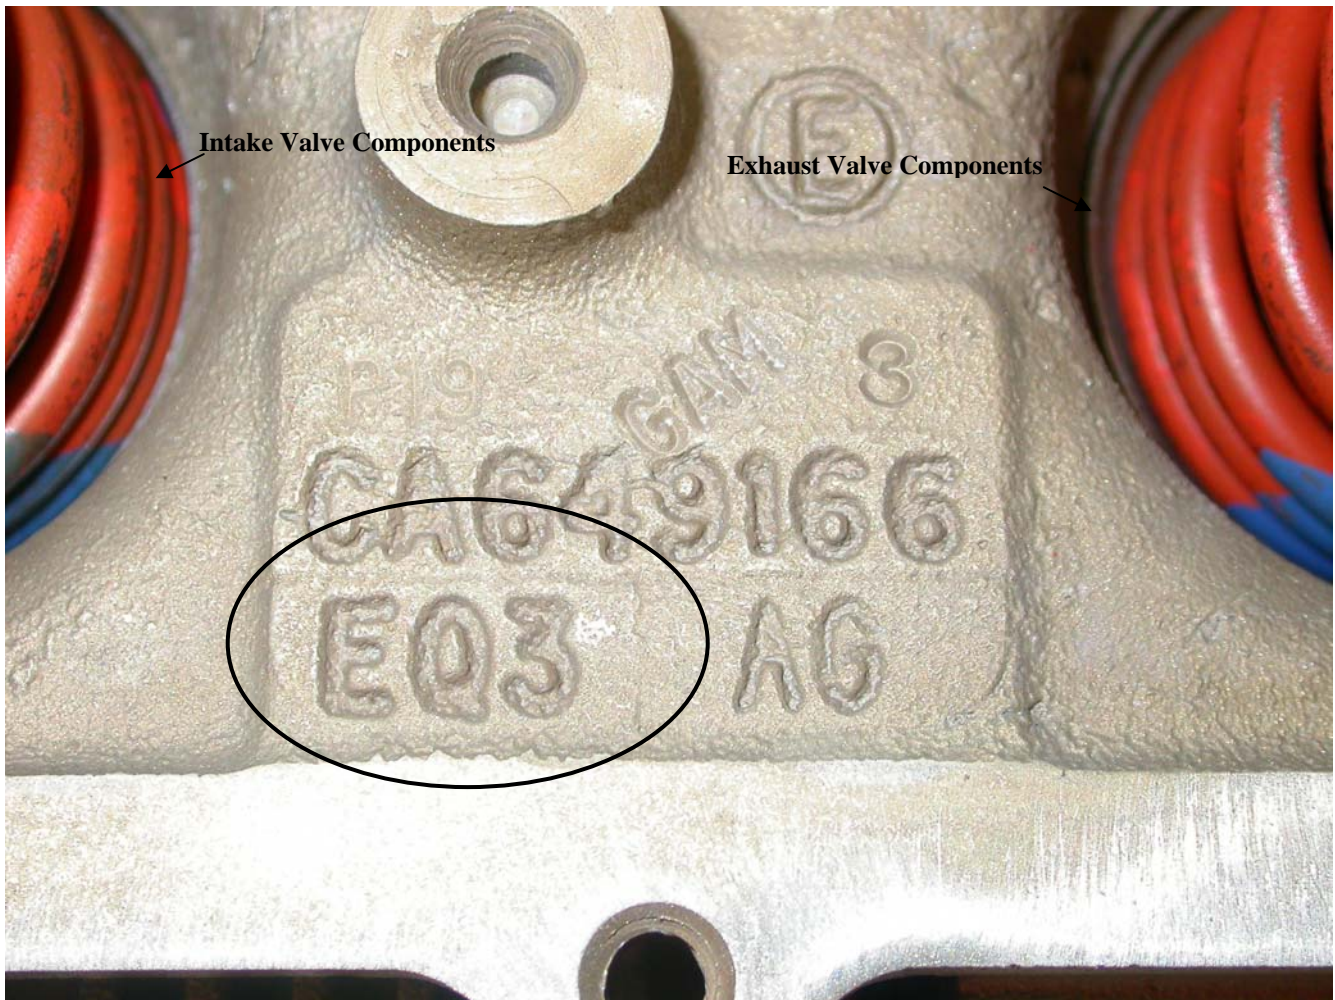
FIGURE 2 Location of EQ3 Marking in the Cylinder Head Rocker Box Overhead Area

1. Cylinders with a depression cast EQ3 in the cylinder head rocker boss area as shown in Figure 2 are covered by this MSB and must be exchanged.
2. Contact TCM in accordance with the completion and registration section below.

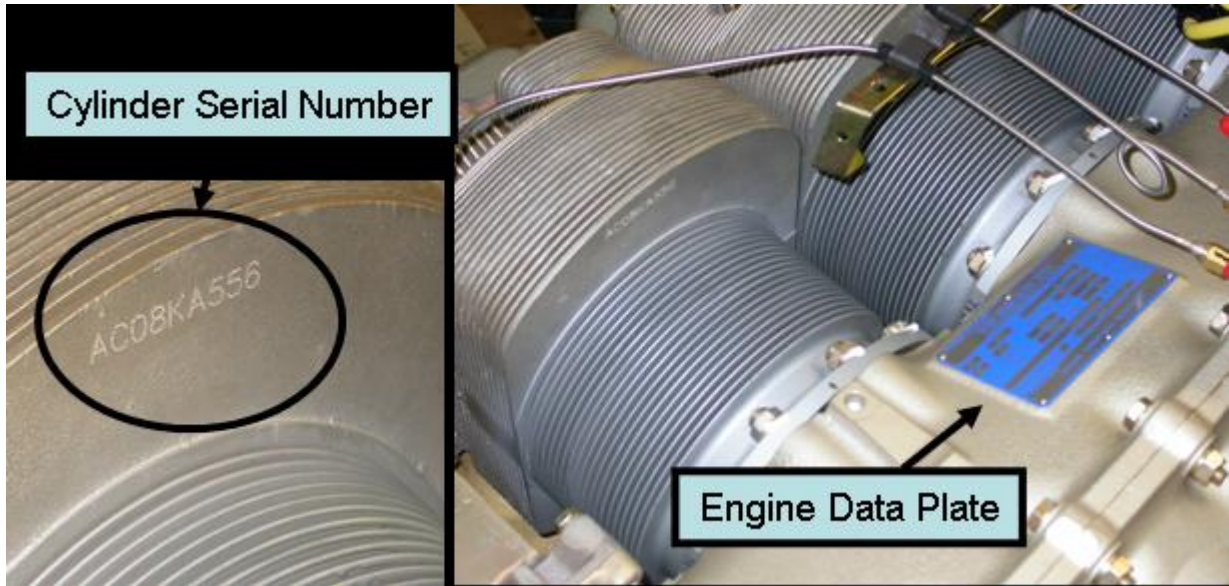
FIGURE 3

Inspect all potentially affected cylinders, within the next twenty (20) flight hours, but no later than April 30, 2009. Verify affectivity of all engine models and cylinders in accordance with Tables 1, 2, and 3. The engine serial number is located on the engine data plate and the cylinder serial number is located on the crankcase side of the top portion of the cylinder head as installed on the engine (Reference Figure 3).

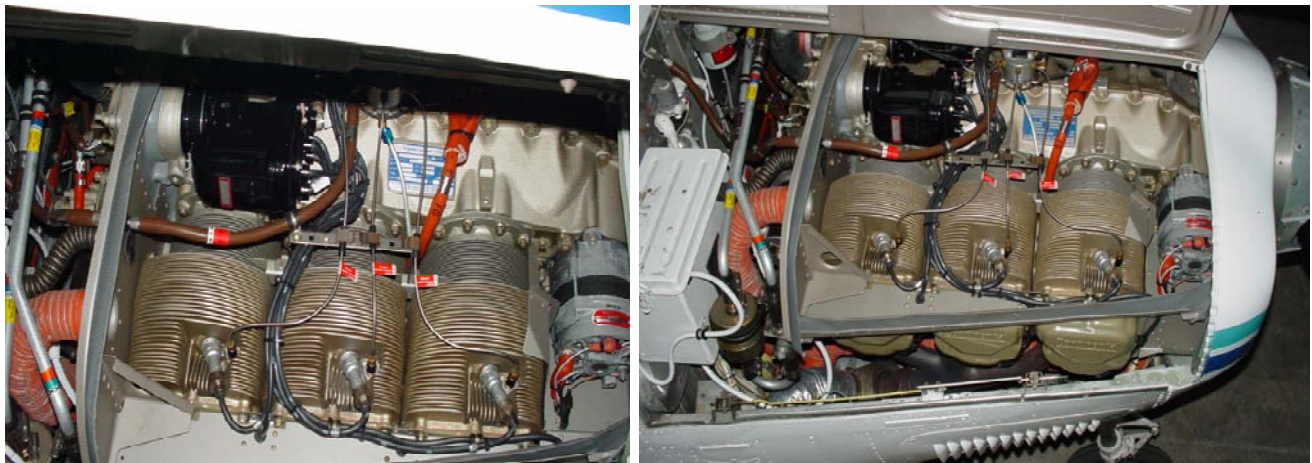
FIGURE 4

- 1. Open or remove the engine cowling in accordance with the airframe manufacturer's instructions to the point necessary to allow visual access to the cylinders on both sides of the engine (Figure 4).

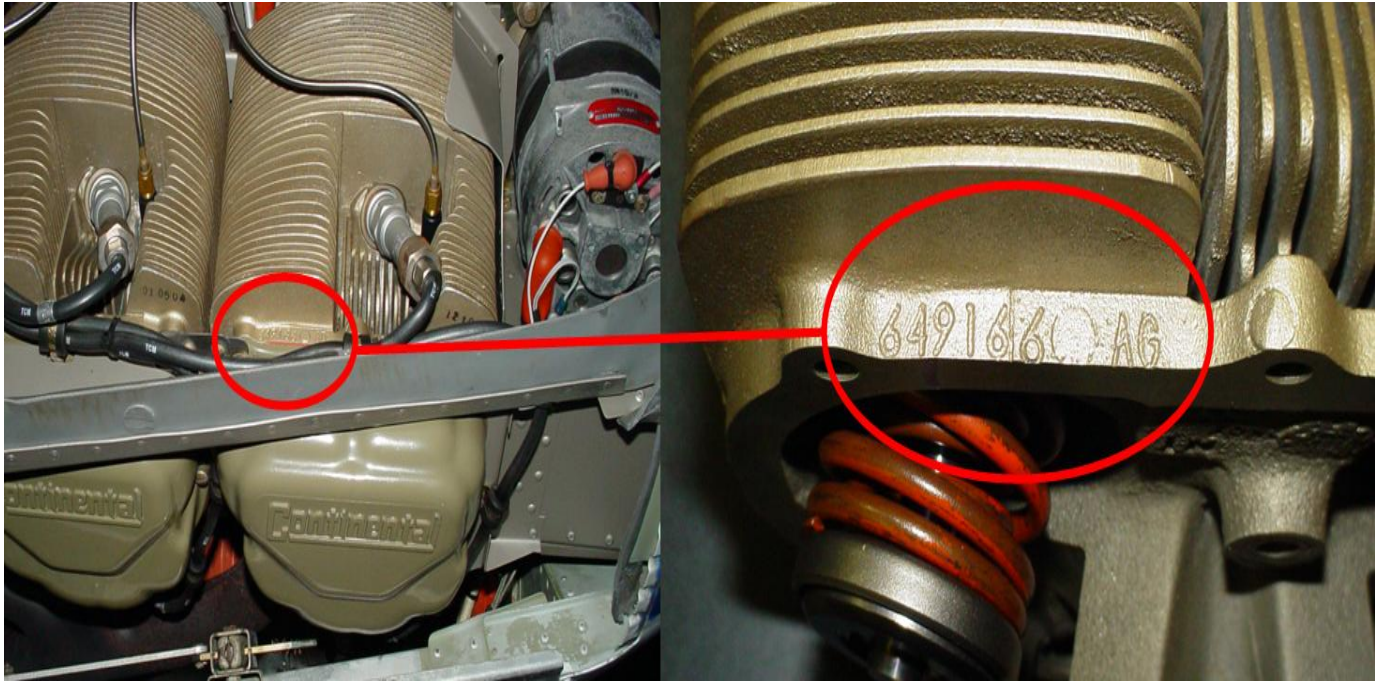
FIGURE 5

2. Access the area of the cylinder head casting as shown in Figure 5. This area is visible as you look down at the cylinders in their mounted condition from above the engine compartment.
 - a. Look for a 6 digit part number casting mark such as “649166” or similar. In addition to the casting mark number, there may be a letter indicator such as AE, AD or similar. (Reference Figure 5)
 - b. If a number casting mark is present, it indicates the cylinder head assembly is not covered by this MSB and no further action is required. . Make an engine logbook entry recording the results of this inspection and compliance with this MSB.
 - c. If a number casting mark **is not** present, then the cylinder may be covered by this MSB. Verify the EQ3 cylinder S/N as shown in Figure 3 is present and listed in Table 2. If so, proceed to completion and registration and **STEP 2**.

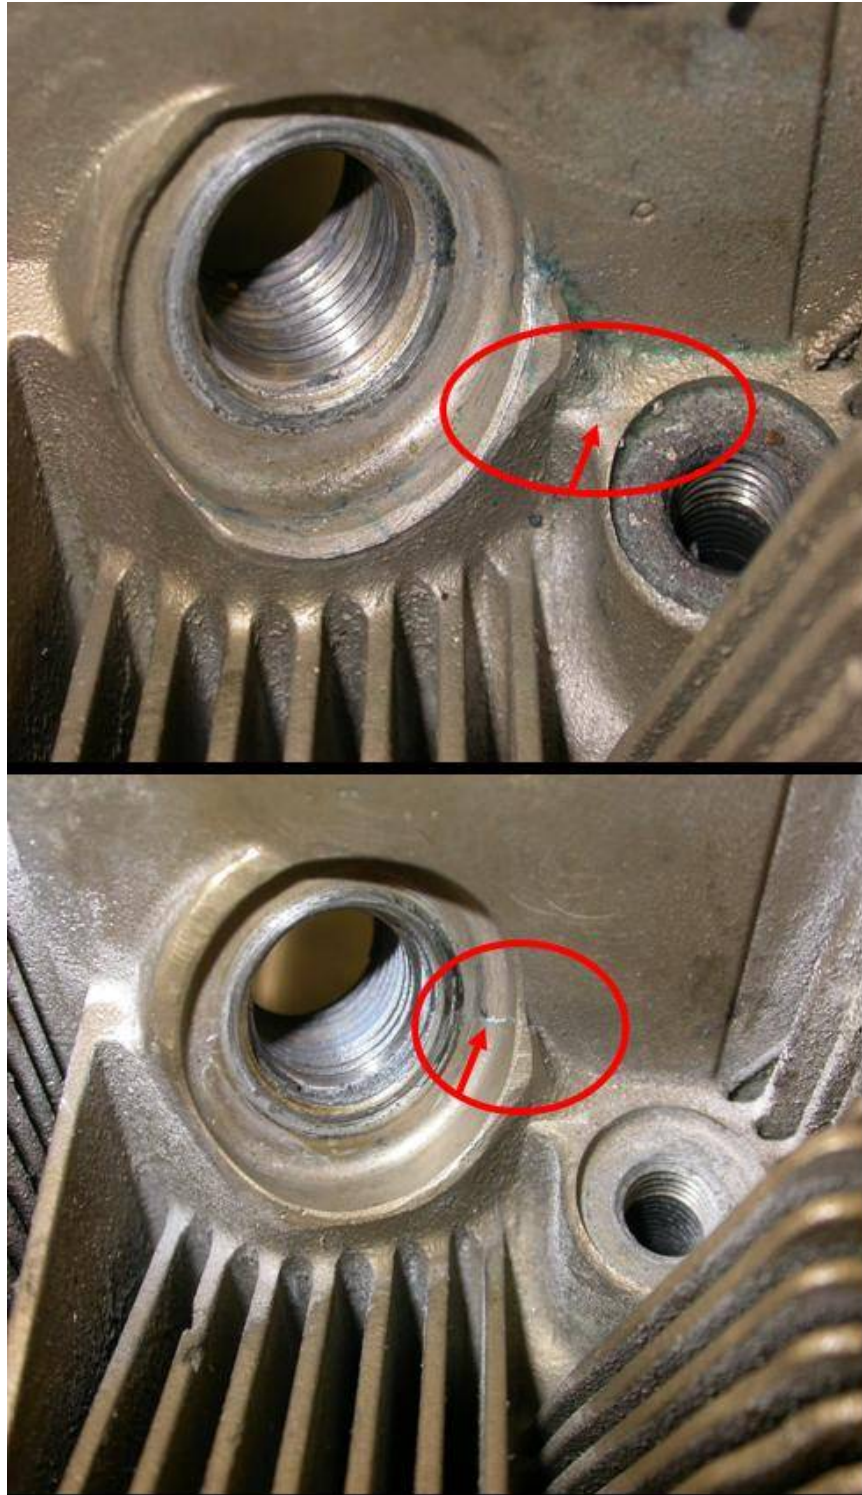
BACKGROUND: As of the date of this Bulletin, Teledyne Continental Motors (TCM) has identified the cause of cracks in 35 cylinders manufactured from November 1, 2007 to January 30, 2009. TCM has determined that the EQ3 cylinder head casting tool used in the manufacturing process created an area of reduced thickness that may result in a crack after prolonged operation. This crack manifests itself in the area between the upper sparkplug bore and the fuel injector/primer nozzle bore. The cracked cylinders returned to date have occurred on engines from high use fleet operations with occurrence times ranging from approximately 430 to 1,300 total hours. Replacement cylinders conforming to proven production history will be provided.

NOTE: Visual evidence of a crack in the inspection area between upper spark plug bore and fuel injection nozzle/primer port as indicated in Figure 6 does not require further verification with a dye penetrant inspection.

FIGURE 6
Typical Visual Crack Indications

- b. Preceding Inspection Reveals Cracks
 - i. If a crack is verified and fuel or combustion staining was noted in the inspection area, contact TCM before further flight.

- ii. Contact TCM via one of the means listed below and on the Customer Information Form to schedule replacement of the affected cylinder(s).
 - iii. If a crack is verified but no evidence is found of fuel or combustion staining, then the engine may be operated for up to five (5) hours for the purpose of relocating the aircraft to a cylinder replacement location.

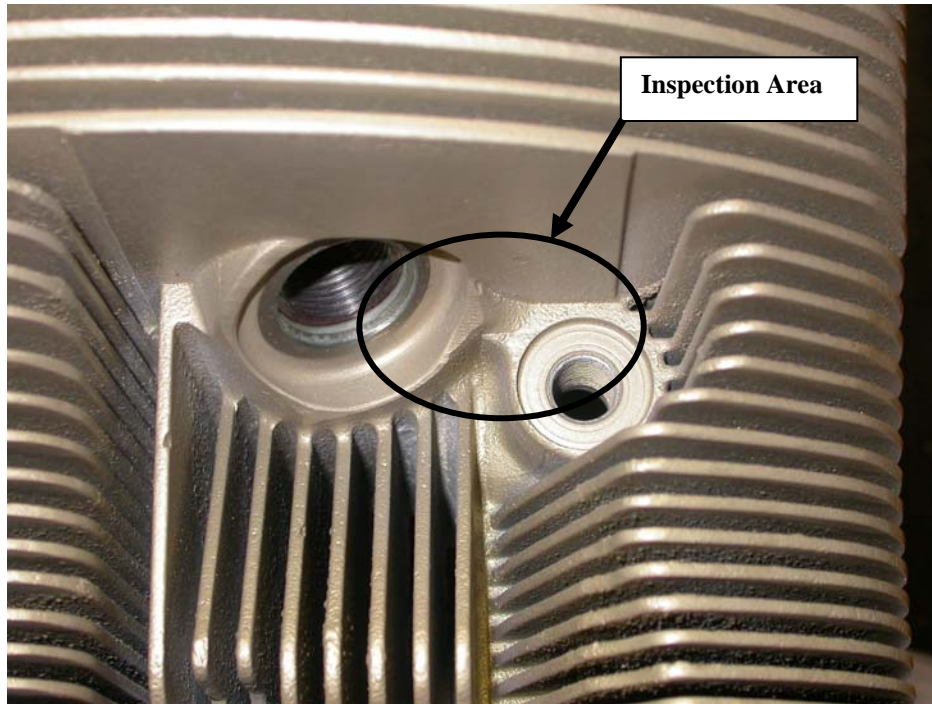
3. Install a protective cap in the top spark plug bore to prevent contamination from entering the cylinder bore area.
4. Using a flashlight and a 10x power magnifying glass, perform a detailed visual inspection of the area between the fuel injector nozzle boss and the upper spark plug. (Reference Figures 6 and 7)
5. If crack indications are found, proceed to step 12(a) below.
6. If no crack indications are noted during the visual inspection or if the mechanic has any questions concerning the presence of cracks in the affected area, proceed to step 7 below.

FIGURE 7
Inspection Area Between Upper Spark Plug Bore and Fuel Injection Nozzle/Primer Port

7. Using Dye-penetrant "Cleaner/Remover", thoroughly clean the area between the upper spark plug bore and fuel injection nozzle/primer port as shown in Figure 7.
8. Spray the "Penetrant/Dye" onto the clean/dry area indicated in Figure 7. Allow the "Penetrant/Dye" enough time to set in accordance with the manufacturer's instructions.
9. Remove and clean the area in which the "Penetrant/Dye" was applied in accordance with the manufacturer's instructions.

10. Spray the “Developer” onto the clean/dry area indicated in Figure 7. Allow the “Developer” enough time to dwell in accordance with the manufacturer’s instructions for the determination of the existence of a crack.

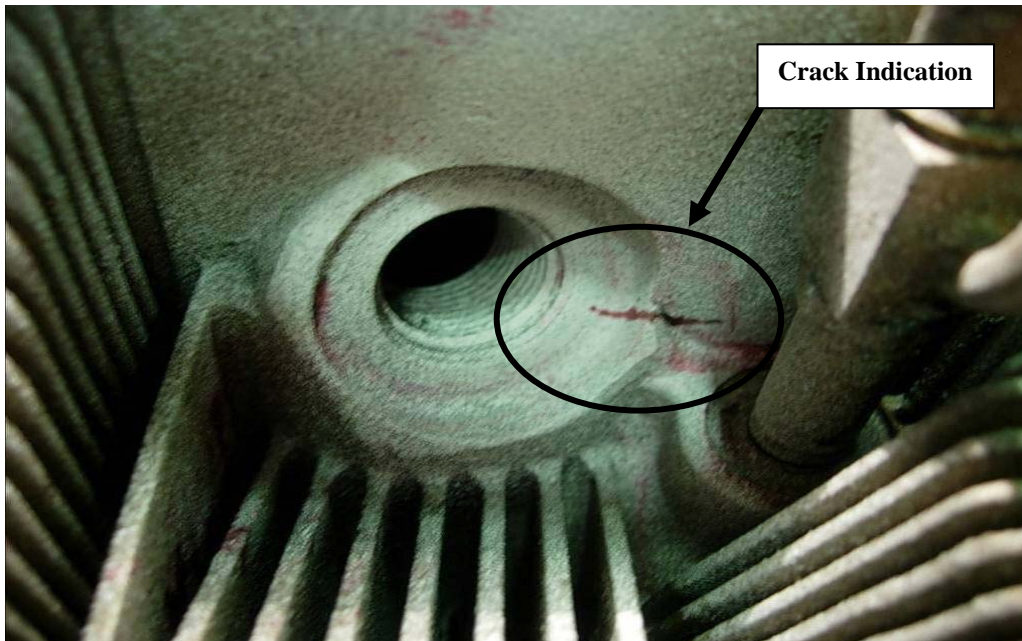
- a. If a crack is present, its appearance and location will be similar to that shown in Figure 8.
 - b. Refer to Step 12, below, for required actions in either a “No Crack Present” or a “Crack Present” case.

FIGURE 8 Cylinder Head Crack Indication with Dye Penetrant
