SERVICE INFORMATION DIRECTIVE

SID 05-1

SUBJECT: THIS SERVICE INFORMATION DIRECTIVE (SID) SUMMARIZES INFORMATION PERTINENT TO THE DESIGN, OPERATION, MAINTENANCE AND WARRANTY FOR TCM CAMSHAFTS AND HYDRAULIC LIFTERS

Teledyne Continental Motors, Inc.

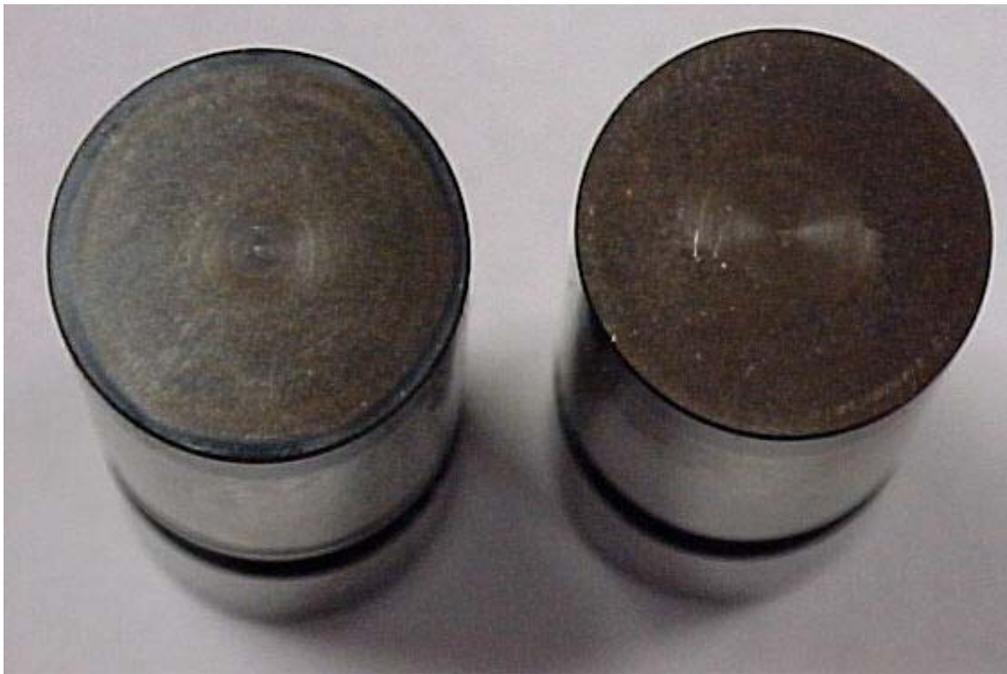
The interface between a cam lobe and lifter is intended to wear to some degree as the engine operates. This is similar to the piston ring / cylinder wall interface that must seat together for proper operation and wear over time. The manganese phosphate will quickly wear off in loaded areas of the cam lobe and the lifter face. Normal wear may take the form of a bright shiny uniform wear surface, with a circular pattern visible on the lifter face. Damage to the lifters is often referred to as “galling” or “spalling”. Localized areas may show signs of spalling or galling in service due to various operating conditions. Some level of such conditions will frequently be found at overhaul. Note that this wear material as with all other normal wear material will be collected by the oil and trapped in the oil filter element or screen

FIGURE 5 TYPICAL LIFTER FACES FROM SERVICE

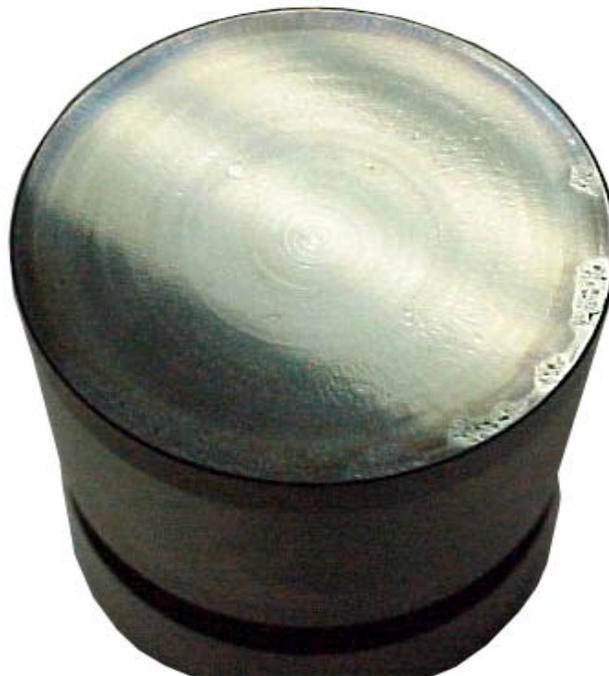
FIGURE 8 ACCEPTABLE LIFTER FACE SIGNATURE

- (7) Remove the hydraulic lifter assemblies from the lifter bores. Mark the lifters for reinstallation into the position from which they were removed.
- (8) If the lifter face and body shows normal signatures, coat with Dow-Corning® G-N paste and reinstall in the same location as removed.
- (9) Reinstall items removed in steps 1 through 6 above (using new tab washers as applicable) using the latest revision of the appropriate maintenance or overhaul manual and the latest revision of Service Bulletin SB96-7 Torque Limits.

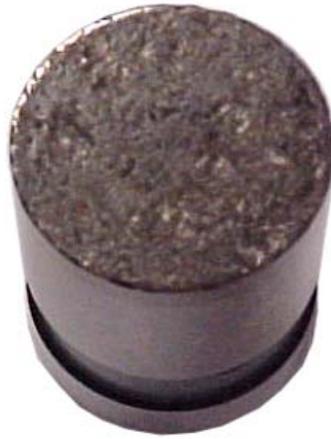
FIGURE 9 REPLACEMENT SIGNATURES, SPALLED LIFTER

Replace lifters with severe face or lifter body wear signatures or spalling that exceeds 10% of the surface area. Lifters associated with noise indicating excessive valve lash should also be replaced regardless of face condition.

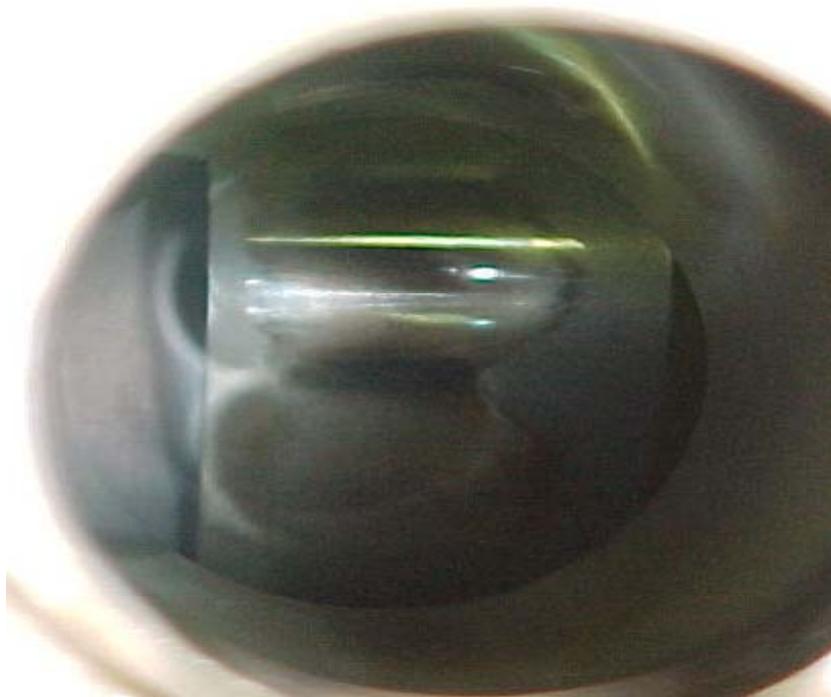
FIGURE 10 CAM LOBE APEX IN INSPECTION LOCATION
(Normal wear signature shown)

- (1) Turn engine so that the apex of the cam lobe is visible through the lifter bore in the crankcase, reference Figure 10.

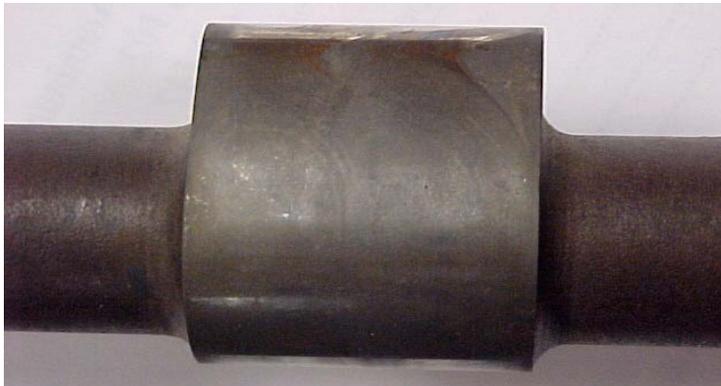
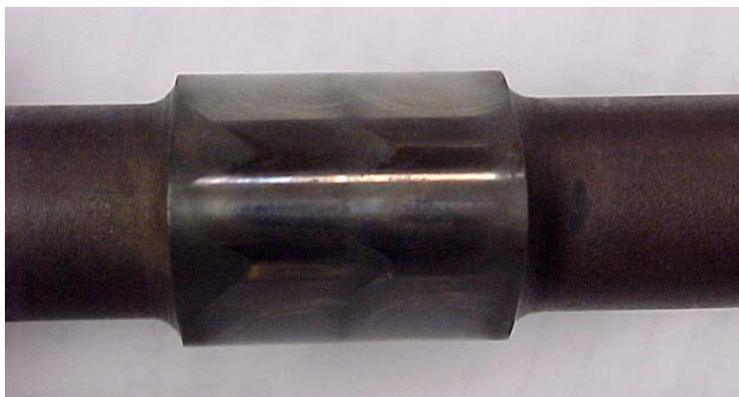
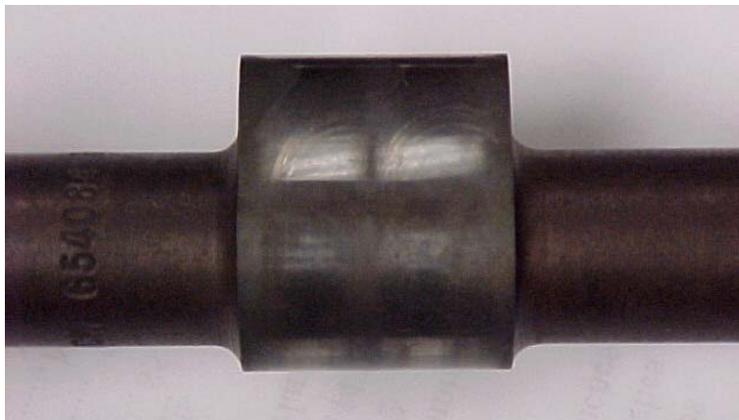
CAM LOBE OPENING FACE

APEX OF CAM LOBE

CAM LOBE CLOSING FACE

FIGURE 11 TYPICAL CAM LOBE WEAR SIGNATURES

(2) Perform visual inspection using an inspection light. If the surface is smooth and shiny with only small areas of rough appearance, no further action is required.

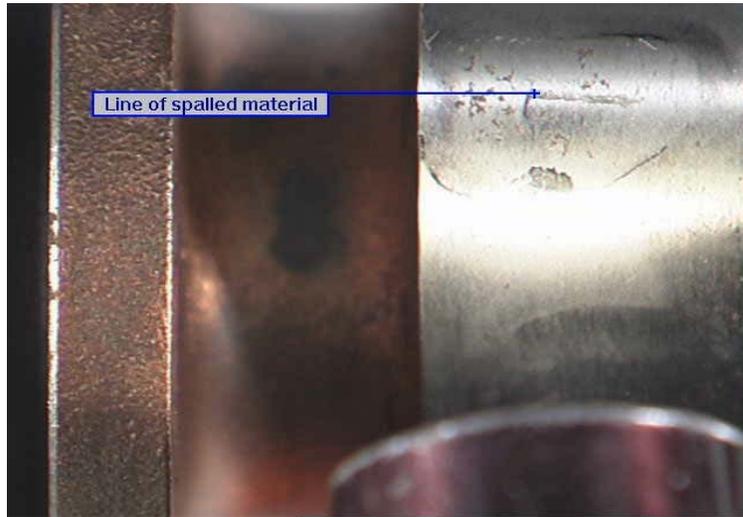
In some cases, significant spalling may result in some damage to the cam lobe apex. This level of damage is rare, but will manifest itself as surface cracks on the nose with some depth. Note that appearance of the cam lobe apex may vary normally, and only if such cracks are present should the camshaft be considered a candidate for replacement. Corrosion (rust) will also cause cam lobe distress. See the INSPECTION SECTION for specifics.

SPALLED CAM LOBE

FIGURE 12 SUSPECT CAM LOBE APEX SIGNATURES

Using a sharp pick, move the point over the nose. If a crack like feature has any depth, the pick will catch in the groove or pits. If no positive indication of a crack is felt, no further action is required. If an indentation is present, the cam must be examined by a TCM service representative to determine the next steps.

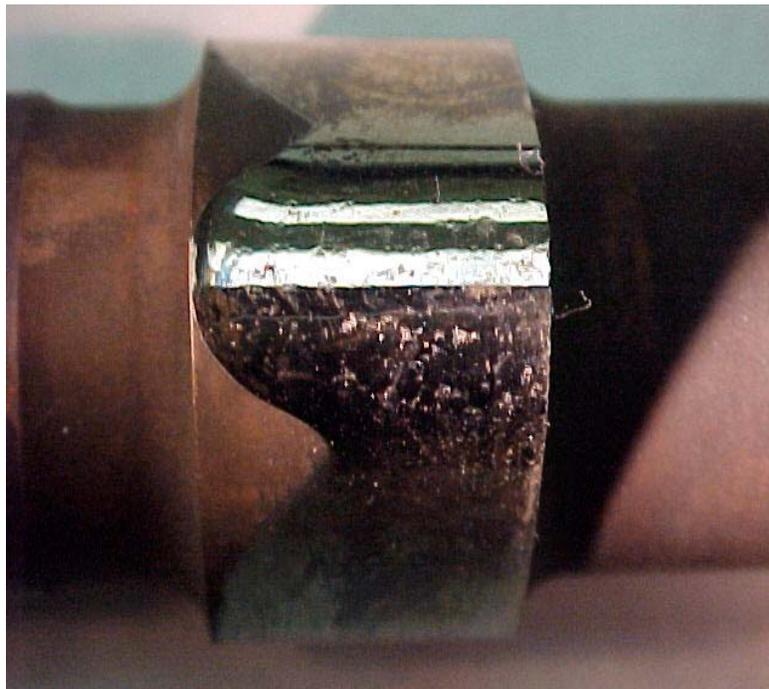
CORROSION PITTED CAM LOBE

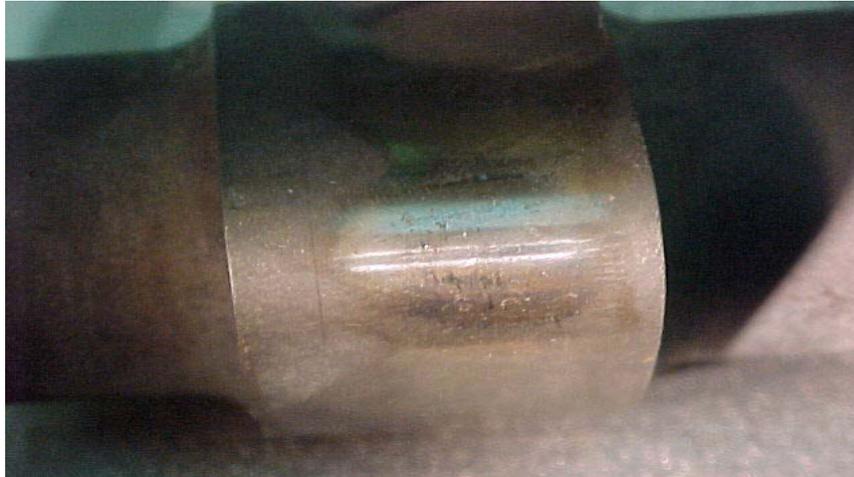
FIGURE 13 CAM LOBE APEX MINOR DISTRESS

For minor distress, the camshaft may be continued in service and re-examined upon the accumulation of 100 hours operation or 12 months, whichever occurs first. If the TCM representative determines the camshaft should be replaced, the engine should be removed for repair. Note that cylinder removal to gain better access may be required to make the final determination.
