POWERPLANT 113: "ENGINE FAILURE FOR UNKNOWN REASONS"

That's what TCM's analytical report said about the catastrophic engine failure suffered last year by ABS member Lowell Powers. Let's see if we can figure out why his engine came apart.

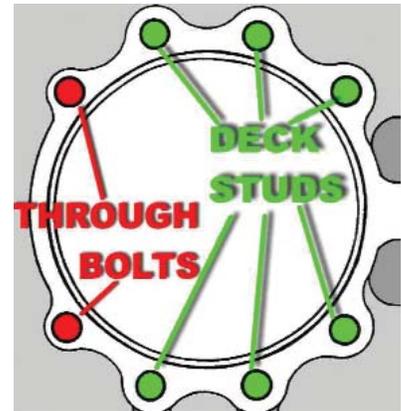
Fig3: Each cylinder is held in place by six deck studs and two through-bolts.

The maintenance shop in New England that performed the annual inspection on Lowell's B36TC removed all three cylinders on the left side of the engine. Removing each cylinder requires removal of the eight cylinder hold-down nuts that secure the cylinder base flange to the crankcase. Six of those hold-down nuts are threaded onto short deck studs that are mounted in threaded holes in the crankcase. The other two hold-down nuts are threaded onto a pair of long through-bolts

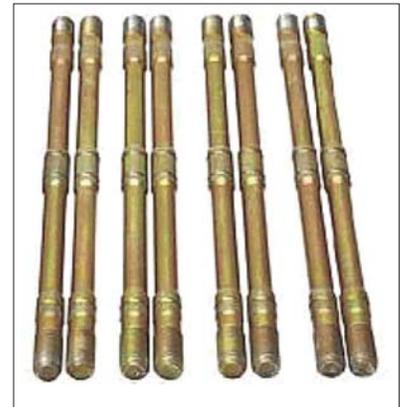
Fig4: Eight through-bolts hold the crankcase halves firmly together.

To understand the cause of this catastrophic engine failure, you need to know something about how the engine is put together. The left and right banks of cylinders are staggered so that each pair of through-bolts run from the front hold-down nuts on a left-bank (even-numbered) cylinder to the rear hold-down nuts on a right-bank (odd-numbered)

cylinder. The engine has four pairs of these through-bolts (Fig. 4), and they are primarily responsible for holding the two crankcase halves firmly together.

If a mechanic removes all three cylinders from one side of the engine by removing all 24 cylinder hold-down nuts (8 per

cylinder), this results in loss of torque on six of the eight through-bolts that hold the two crankcase halves together. If the mechanic rotates the crankshaft while the engine is in this precarious state—to position each successive piston to bottom-dead-center to facilitate removal of the associated cylinder—there is a serious risk that the main bearings will shift in their saddles.

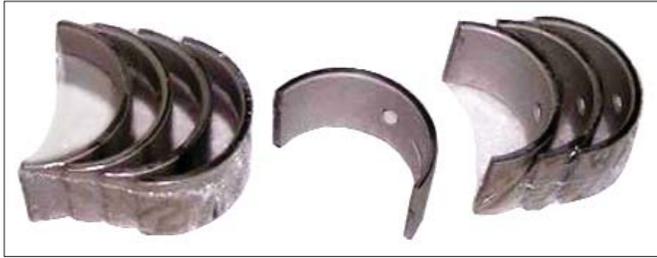
The crankcase contains precisely machined semicircular main bearing saddles that hold the main bearings that support the crankshaft. The main bearings are semicircular shells (Fig. 5) that consist of steel back plates laminated to bearing surfaces made of a softer material called "babbitt" that won't scratch the crankshaft journals. The main bearing shells have

Fig5: Main bearings are semicircular shells held in place by through-bolt torque.

oil supply holes that must line up precisely with oil passages machined into the crankcase halves.

When the engine is assembled, the ends of the main bearing shells stick out slightly above the mating surfaces of the crankcase bearing saddles. As the case halves are mated during engine assembly by torquing the through-bolts, the bearing shells are forced firmly into the crankcase saddles in an operation known as “crushing.” Once the bearings are crushed in place during engine assembly, it is absolutely essential that they not be disturbed.

If the bearings shift, the oil holes in the bearing become misaligned with the oil passages in the crankcase, partially cutting off the oil supply to the bearing. If the engine is then put back into service, the reduced oil supply to the bearing causes increased heat and friction that can result in the bearing shifting more, further reducing its oil supply. Ultimately, the bearing can shift enough to cause the oil supply to be cut off completely, and the result is invariably a catastrophic failure of exactly the kind that Lowell’s engine suffered. This phenomenon is usually referred to as a “spun bearing.”

After reading the TCM analytical report several times, talking to Lowell, and looking at the photos he took of the engine after his forced landing, there’s no doubt in my mind that this is exactly what happened to his TSIO-520-UB engine. In my opinion, this was a classic maintenance-induced failure.
