By George Brown

Fuel Cap O-Rings

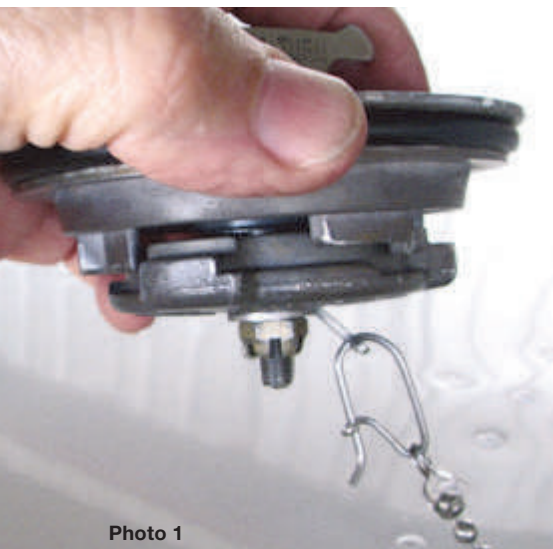
Photo 1

of the cap to the cap adapter in the wing plus a small internal O-ring that seals the rotating shaft within the cap. **Photo 1** represents a Shaw 531 cap and shows the location of these O-rings plus the cotter pin that secures the castellated nut at the bottom of the cap. The O-rings in the other caps are in identical or similar locations.

After we acquired our Baron I was surprised to find that the small O-rings inside both of the Shaw 531 caps had deteriorated. According to the airframe logs, every annual inspection hosted replacement of the large external O-rings, but there was no mention of the small internal ones. Out of simple curiosity, after moving the first cap to my workbench I poured a small amount of light oil into the recess in the top of the cap. The oil immediately ran down into the cap and began flowing out the bottom at the axle. Had the small O-ring been good, the oil would have remained in the recess and not leaked into and through the cap. Luckily, no water had accumulated in the fuel tanks because of the deteriorated O-rings in both caps.

Unlatch the cap from the wing and disconnect it from the safety pin-style hook (**Photo 1**).
