Beech on a Budget

By Mike Caban

The Dreaded Fuel Bladder Leak

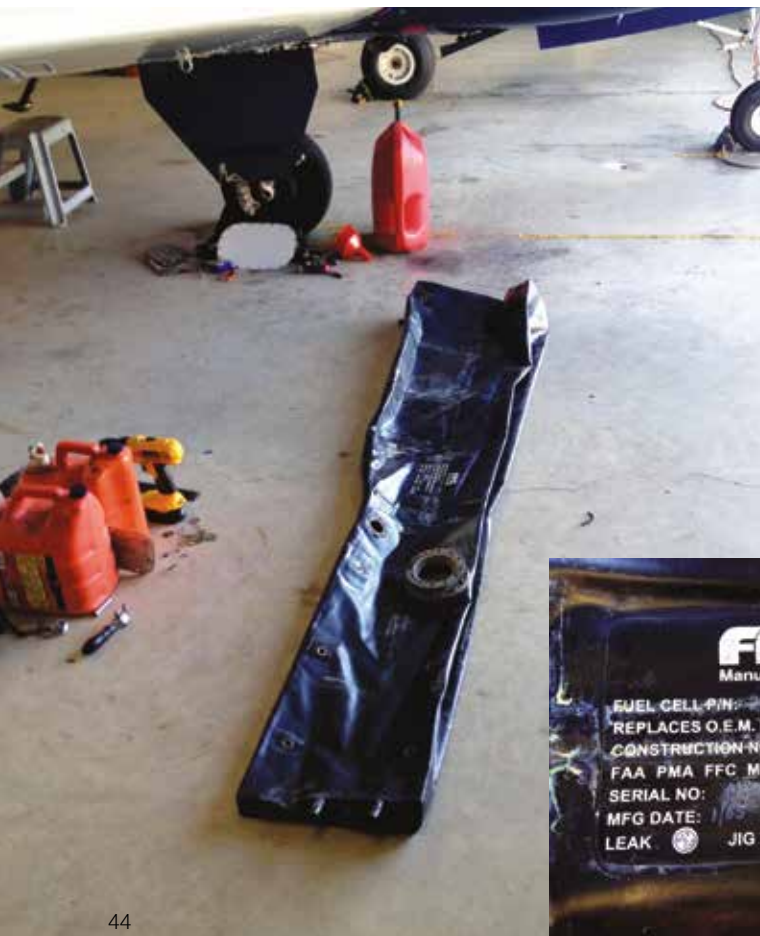
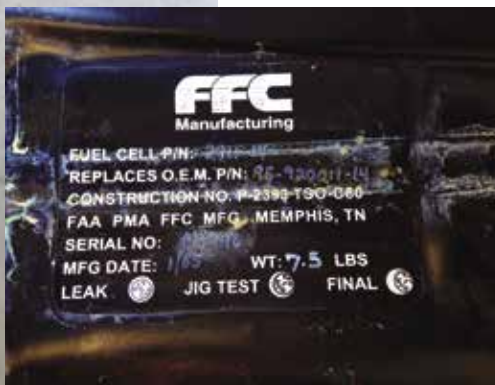
Figure 1

Shortly after purchasing my B55 Baron in 2004 the left auxiliary cell developed a leak. The labor charge at a repair shop was on the order of \$1,000! Add another grand for the fuel cell itself and you can see where this is headed. There goes the equivalent of about 500 gallons of avgas or about 30-something hours of Bonanza fuel, or 20+ hours in a Baron. If that wasn't enough fun for me, in early 2005 the *right* auxiliary fuel cell started leaking. Both cells were original equipment, so after 40 years of service, they didn't owe anyone anything. With the "shock and awe" experience of the left fuel cell replacement under my belt, I solicited the help of my IA for an "owner-assisted" change out. Even with the two of us it was still about a 12-14 hour event. I purchased both auxiliary fuel cells from Floats and Fuel Cells, Inc. (FFC), <http://ffc-fuel-bladders.com> (**Figure 1**).

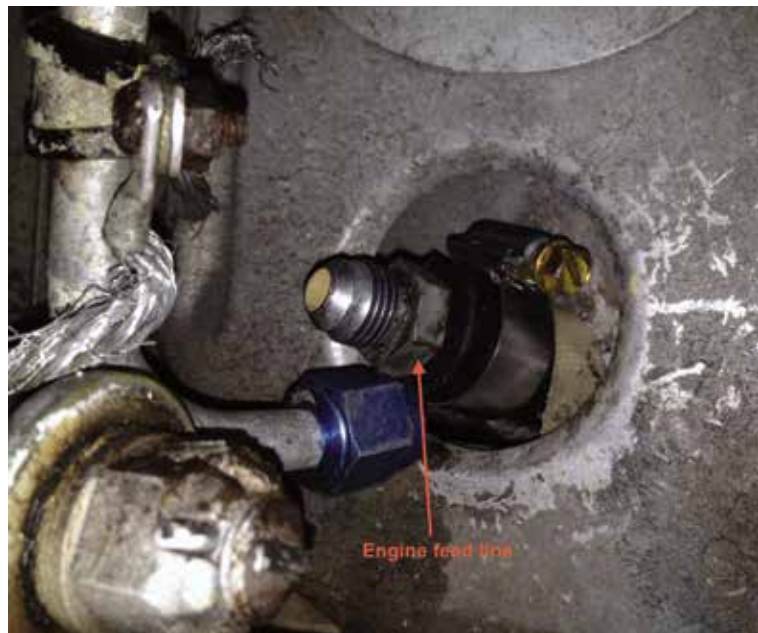
Figure 7

In my case, there are four nipple ports in the aux tank: Feed to selector valve (**Figure 7**), sump drain line (**Figure 8**), fuel return, and tank vent (**Figure 9**). The feed and sump nipples are inboard and the fuel return and vent nipples are outboard.

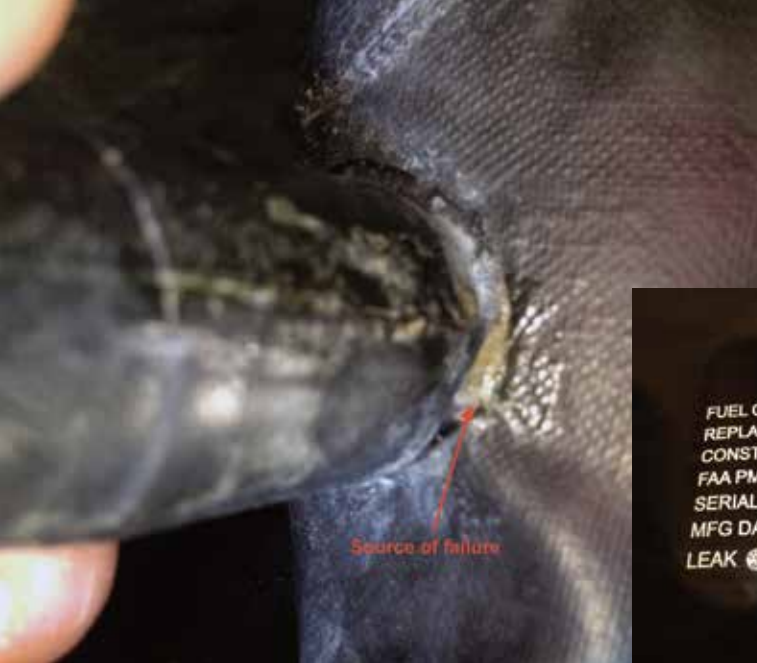
Figure 11

In the process of lifting the cell, some remaining fuel sloshed into the forward main corner where the main feed nipple is located. I immediately began to see and feel fuel dribbling out of the main feed nipple area. This was quite disappointing given that this cell was just barely 8.5 years old and the failure seemed to be in an area that is relatively rigid and almost always wet with residual avgas. Whatever the cause, the cell had to be removed.

openings in the box cavity. Wiggling and gentle tugging on the cell can preserve the nipple joints during extraction in case the cell is serviceable. In my case the culprit associated with my leak is shown in **Figure 11**, the main fuel outlet nipple.

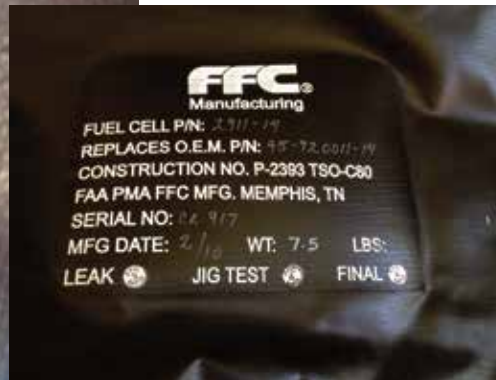
Figure 12

in their future as well. Given the time necessary to make the repair, FFC was kind enough to offer me a completely refurbished cell and an installation kit (clips, gaskets clamps, and tape) for the cost of the repair. Given that they had a 2010 vintage overhauled cell on the shelf

to send me (**Figure 12**), I gladly accepted the deal. Upon receipt of the cell I immediately inspected the nipple joints and could see a dramatic difference in the reinforcing used in this overhauled unit (**Figure 13**). This is what FFC's Director of Sales and Marketing called "continuous improvement."
