By George Brown

Fuel Cap O-Rings

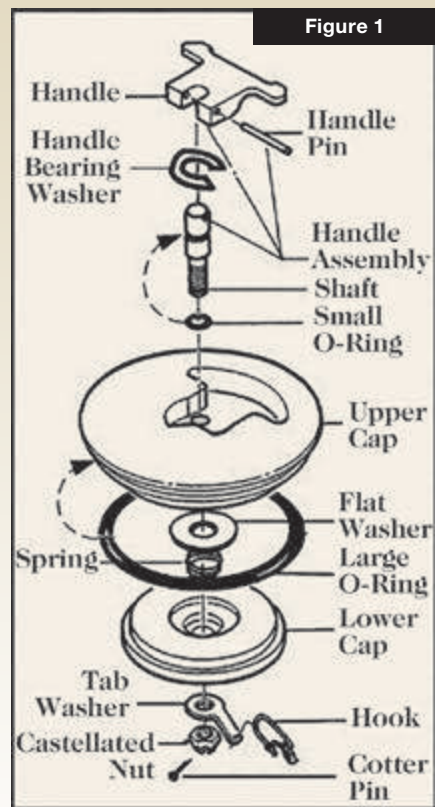
Figure 1

of the cap to the cap adapter in the wing plus a small internal O-ring that seals the rotating shaft within the cap. **Photo 1** represents a Shaw 531 cap and shows the location of these O-rings plus the cotter pin that secures the castellated nut at the bottom of the cap. The O-rings in the other caps are in identical or similar locations.
