26 EASY WINTER PROJECTS FOR THE A36

BY PETER TRACY, BISHOP, CALIFORNIA

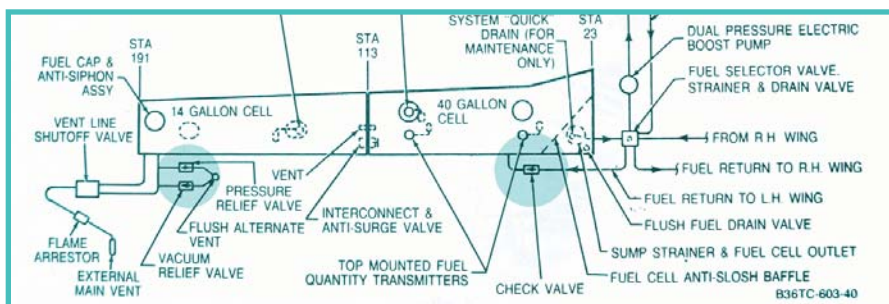
Check valves - Maintenance Manual: Chapter 28-20-00.

3. CLEAN OR REPLACE CHECK VALVES. There are two check valves in the wings—siphon break valves. One in the fuel return line. Sweeney Check valves. Fuel Return Line: P/N 50-380170-11—on firewall. Siphon break valves: P/N 34-1300-1 (P/N: 50-380170-11.) in fuel vent lines outboard of wing tanks and accessible through inspection panel under wing. These tend to gum up in time. One-way door valve. Can usually be cleaned. Make sure the

right side is up—hinge on top. Good solvent. Parts Manual: Figures 281-281C and 282-282C. Maintenance Manual: Chapter 28-20-00.

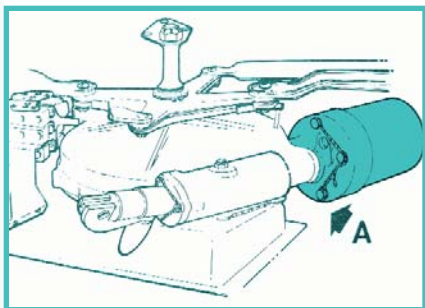
Landing gear motor - Parts Manual: Figures 214-214B

11. REMOVE AND OVERHAUL LANDING GEAR MOTOR. Relatively easy. Under main spar cover under pilot's seat. Unhook wires. Unbolt motor. Motor is .50 Cal. machine gun belt feed motor. Motor will get weak. May lose dynamic brake. Cruisair can overhaul. Beech recommends overhaul at 2000 hours and brush replacement each 500 hours. Check your gear retract times. New from Raytheon: \$2,459.66. Field overhaul cost is about \$500; \$800 for a factory-repaired unit. Motor P/N 96-380022-5, superseded by P/N 58-380090-1. Parts Manual: Figures 214-214B. Maintenance Manual: Chapters 32-20-00 and 32-30-00.

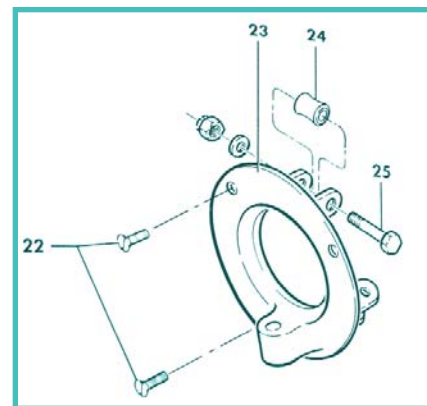
Control column rollers - Parts Manual: Figures 155-155A.

17. REPLACE CONTROL COLUMN ROLLERS AND HARDWARE. Very easy job. Pull collar from around control column—three screws. Pull collar back. Column rides on three nylon rollers. They tend to compress and wear over time. New rollers: P/N 35-524197-4. (\$16.57 each from Raytheon.) Rollers ride on three bolts, nuts, washers. Bolts: 130909B23/M; Nuts: 130909N29/M; Washer: AN960-10L; Screws: AN507-832-10. Parts Manual: Figures 155-155A. Maintenance Manual: Chapters 27-10-00, 27-11-00. Not applicable to A36s built from 1984 forward.

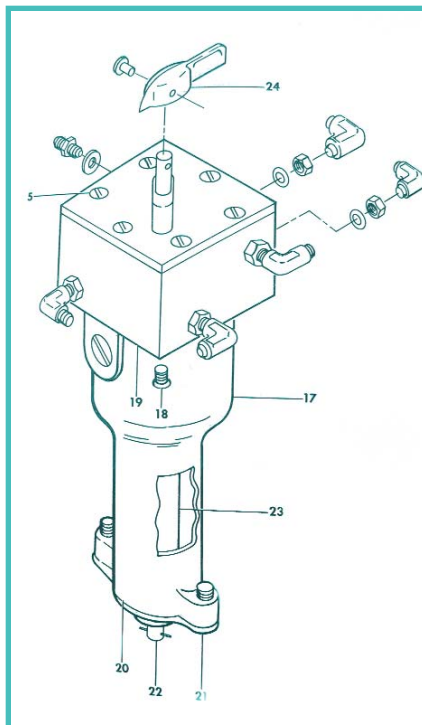
Fuel selector valve - Parts Manual: ---Figure 289A-289C.

22. REMOVE & OVERHAUL FUEL SELECTOR VALVE. Fuel selector valve removal requires a/c to be de-fueled. Remove valve. Send out for overhaul. Cost: About \$200. Beech recommends overhaul every 10 years. Parts Manual: Figure 289A-289C. Maintenance Manual: Chapter 28-20-00. Procedures: Drain and purge fuel system. Remove pilot & co-pilot seats. Remove royalite cover over main spar. Remove fuel selector handle & unscrew postlight covers from the royalite truss cover, then remove the truss cover. Disconnect the fuel plumbing from the fuel selector valve. Remove the four bolts securing the auxiliary fuel pump to the mounting bracket & remove the auxiliary fuel pump. The auxiliary fuel pump is located in front of the spar carry-through on the pilot's side.
